City of Baltimore Wet Smoke and Dyed	Page 1 of 2	
Sewershed: Gwynns Falls	Date: 4/20/2009	
Test to be performed: Smoke Dyed Water X	Ground Condition: Dry ✓ Damp □ Wet □	Supervisor: JAW
Manhole_ID: S05II1015MH	Test ID: <u>D1032-034041</u>	Notification Made: NA (Residents, Fire, 311)

City of Baltimore Wet Weather Consent Decree Smoke and Dyed Water Testing Form					Page 2 of 2
Sewershed: Gwynns Falls			Company: Savin		Date: 4/20/2009
Test to be per	rformed: Dyed Water <u>X</u>	, <u>:</u>	Ground Condition: Dry ✓ Damp ☐	Wet	Supervisor: <u>JAW</u>
Manhole_ID:	<u>S05II1015MH</u>		Test ID: <u>D1032-034041</u>		Notification Made: NA (Residents, Fire, 311)
104.4000015	03		Infil Runner	@ jt, no o	dye seen
110.0999985	03		Infil Runner	@ jt, no o	dye seen
113.0999985	10		I1 Infil Runner	@ jt, no o	dye seen
116.4000015	09		Infil Runner	@ jt	
116.4000015			Dye Test Visible	@ IR, 0.1	gpm, dye is intermittent
119.4000015	02		Infil Runner	@ jt, no o	dye seen
125.6999969	08		Infil Runner	@ jt, no d	dye seen
134.1999969			Abandoned Survey	COMPLE	TED DYE FLOOD

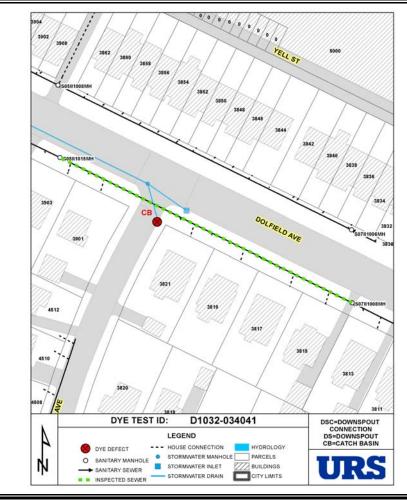
Field Sketch: Show all manholes with Numbers, Blower Placement Locations, Sandbag or Isolation Locations, Street Names, Building Addresses and Locations, Defect Locations and Photo Numbers.

Defect Loc	Obs_ClockFrom	Obs_ClockTo	Observation	Obs_Remarks	
0			Start of Survey		
0			Manhole	S05II1015MH	
0			Water Level		
92.40000153	10	02	Infil Gusher		
92.40000153			Dye Test Visible	@ IG, 5gpm	
94.59999847	10	02	Infil Gusher	@ jt	
94.59999847			Dye Test Visible	@ IG, 3.5gpm	
98.30000305	11	01	Infil Gusher	@ jt	
98.30000305			Dye Test Visible	@ IG, 2gpm	
101	02	10	Infil Gusher	@jt	
101			Dye Test Visible	@ IG, 5gpm
